North Coast Regional Water Quality Control Board

**September 26, 2018 Warrant Inspection
Trinity County Assessor's Parcel Number (APN) 020-520-18-00**

File: Cannabis Inspections, Trinity County, 2018, 180926 Eng Lia Her,
APN 020-520-18-00, CIWQS Place ID No. 856706.

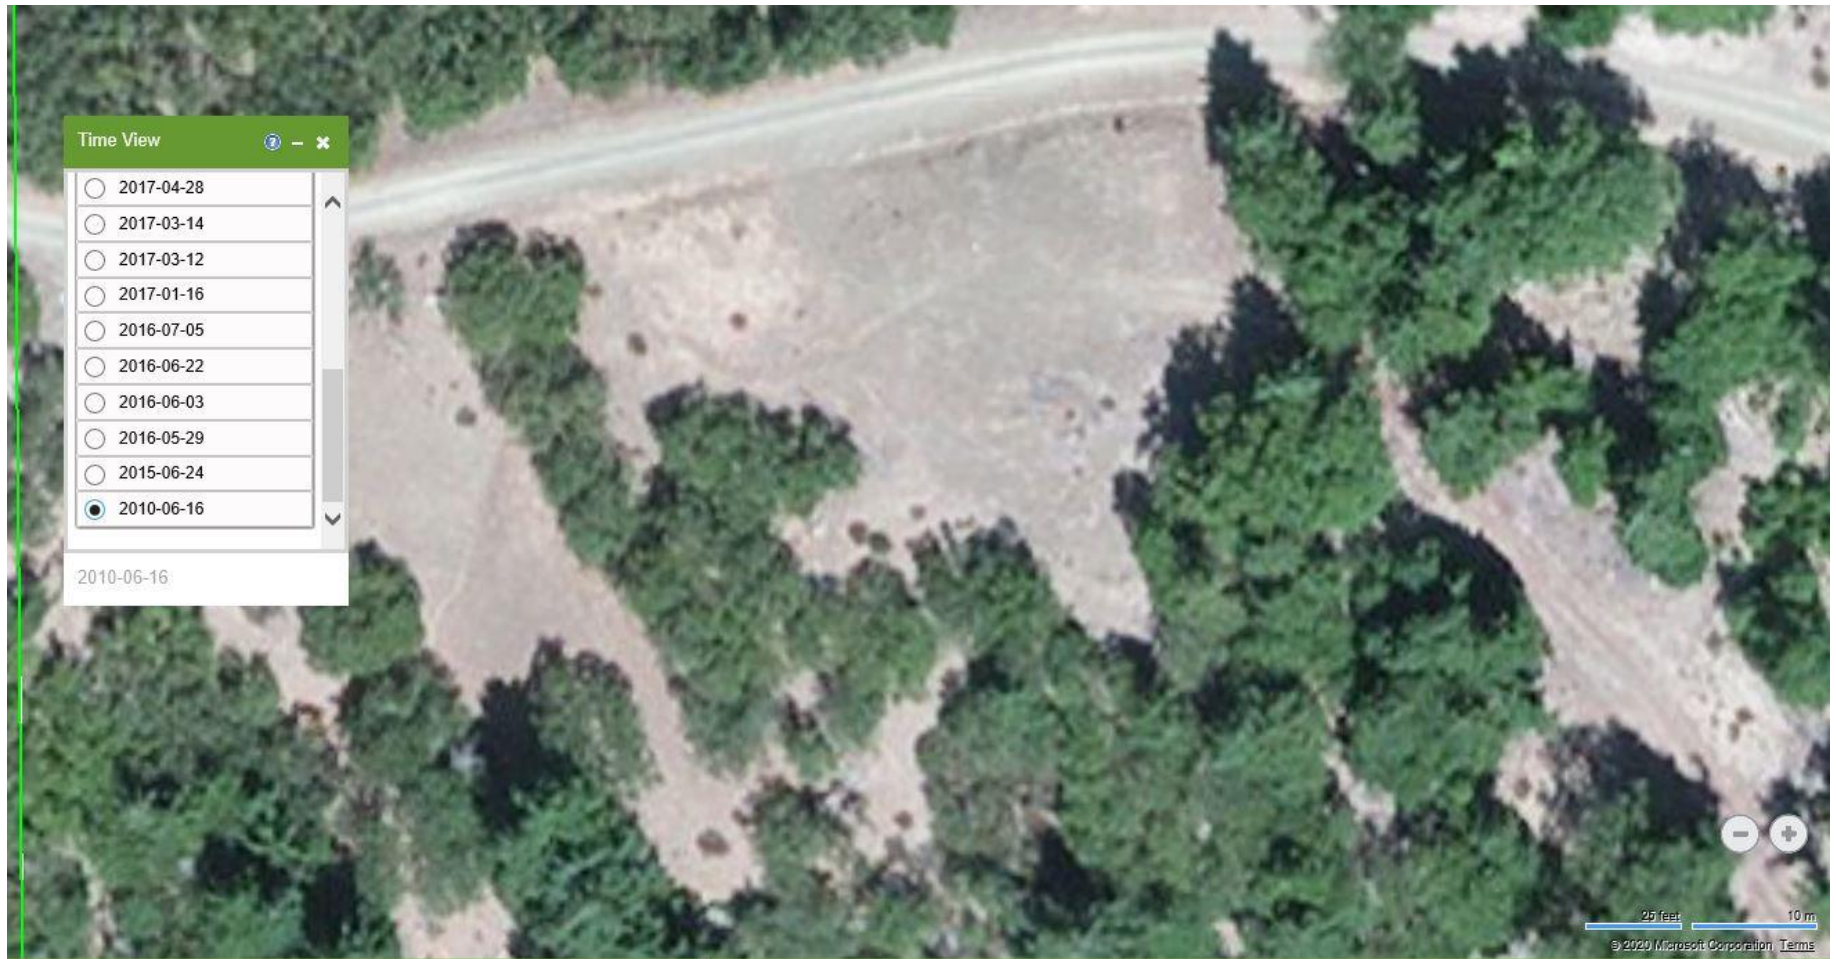
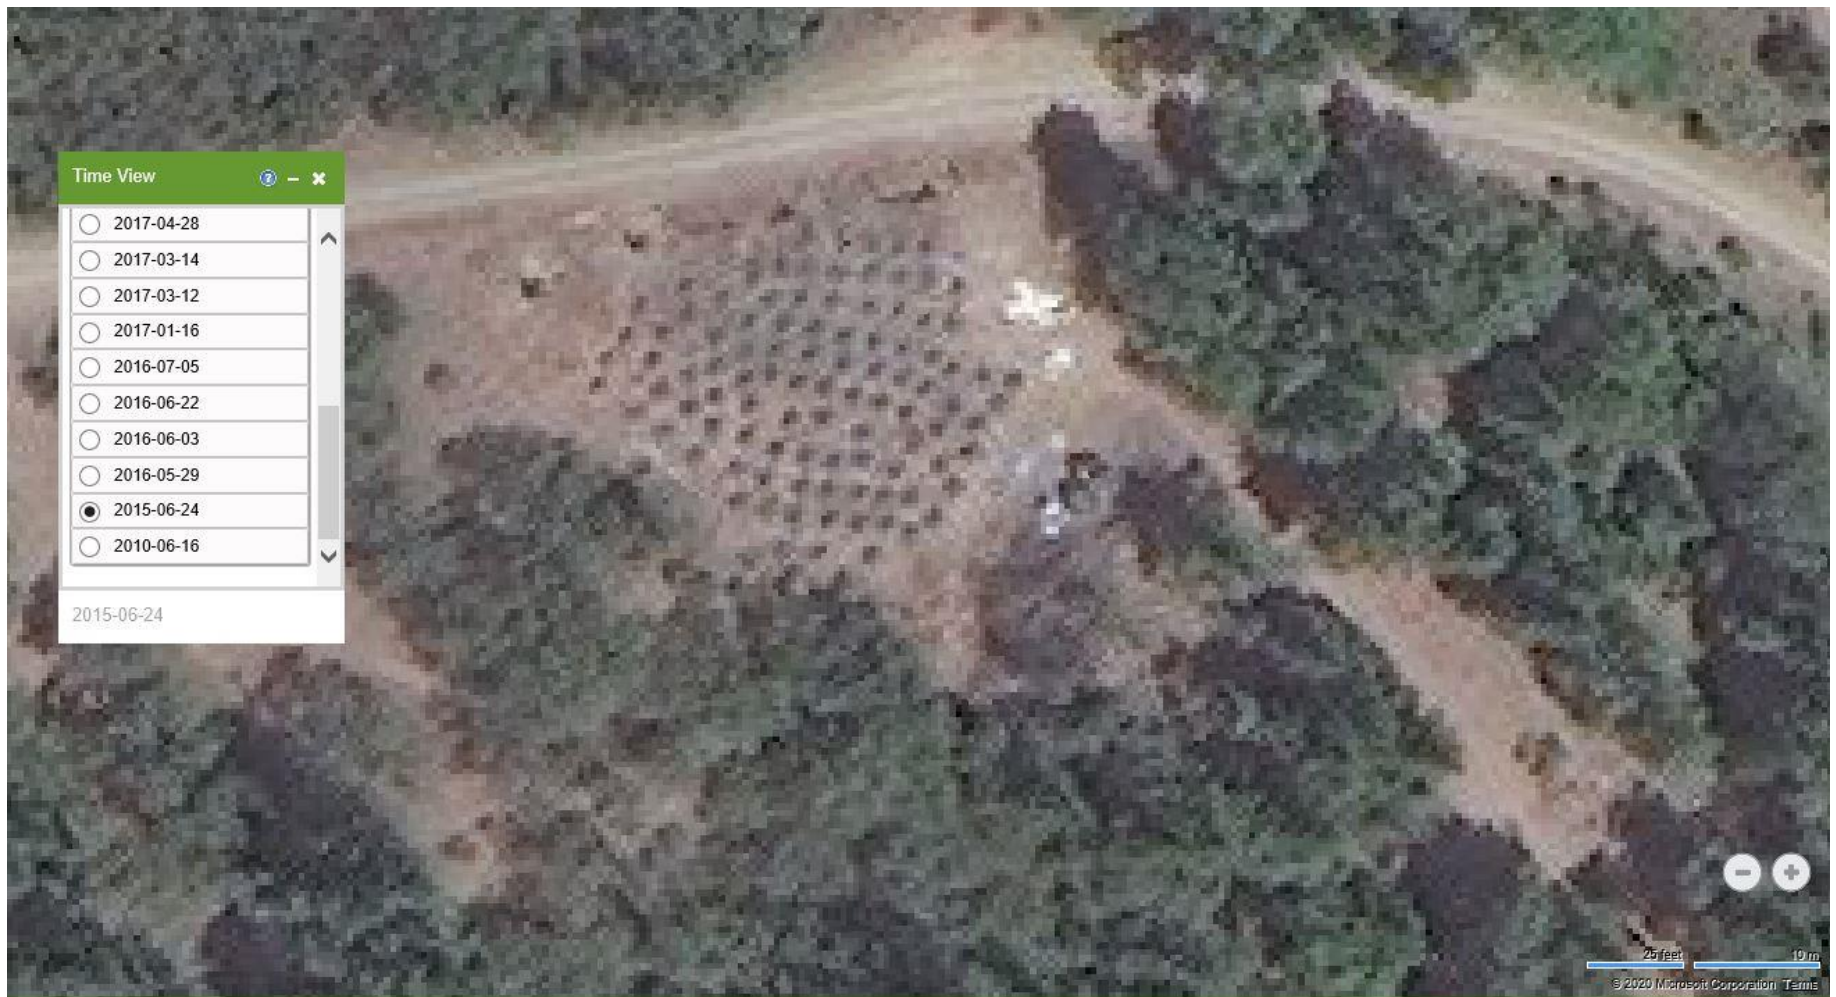
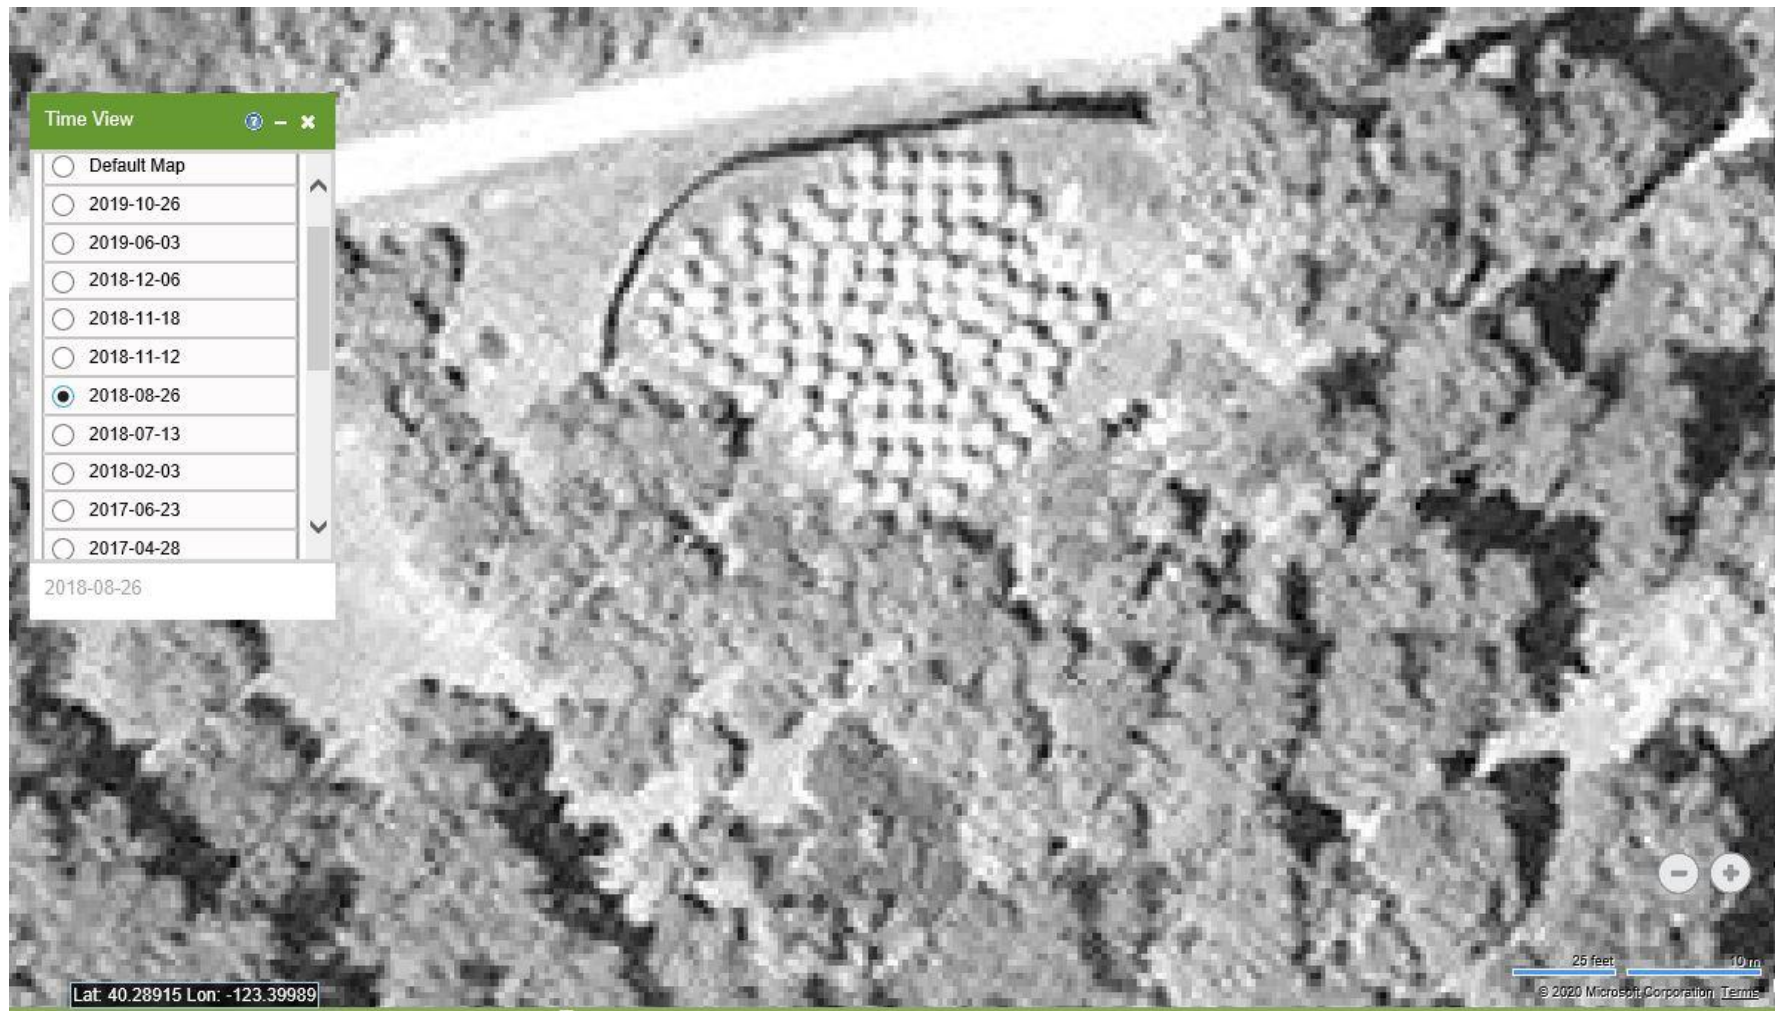
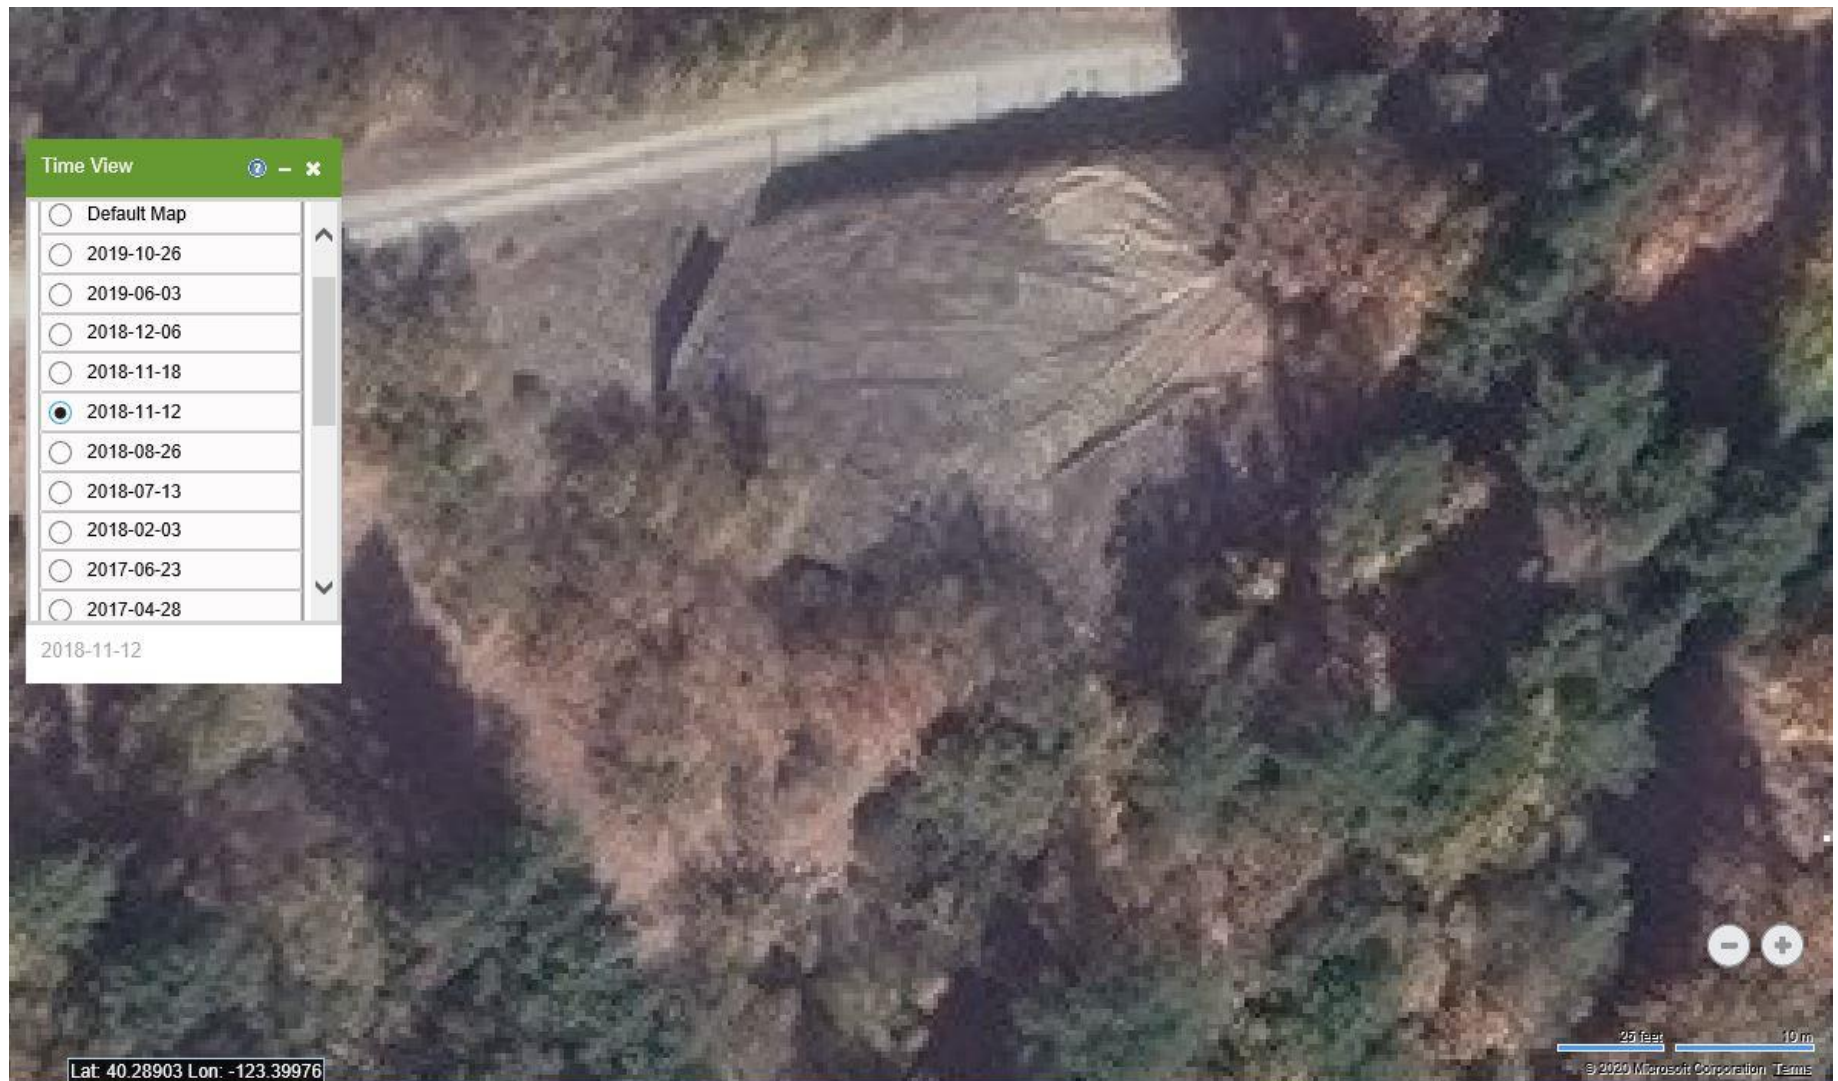
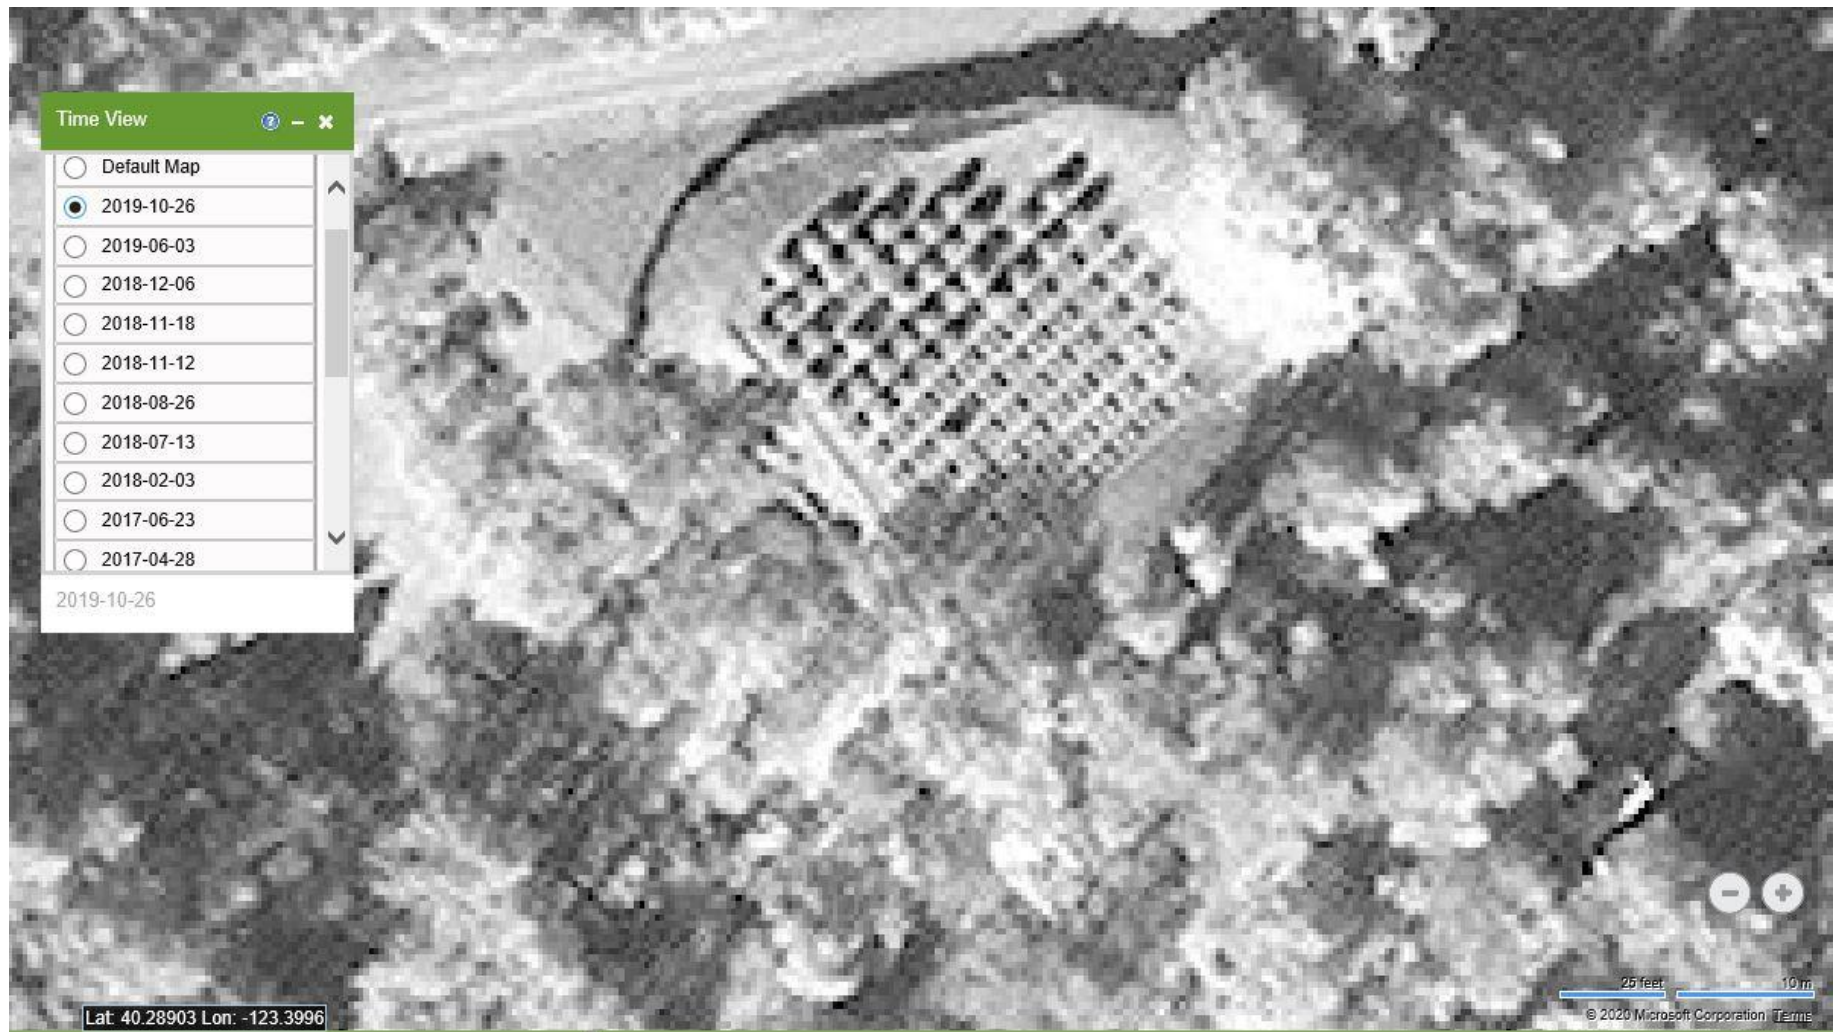
Patterns consistent with cannabis cultivation (cultivation) can be seen in two areas, (see WQ 1 and WQ 2 in Figure 1) beginning between June 16, 2010 and June 24, 2015. cultivation in both areas was cleared following the September 26, 2018 inspection. Cultivation is apparent in the northern area on October 26, 2019.

Aerial Image 1—Northern cultivation areas dated June 16, 2010, accessed with Digital Map Products' Land Vision service.

Aerial Image 2—Northern cultivation areas dated June 24, 2015, accessed with Digital Map Products' Land Vision service.

Aerial Image 3—Northern cultivation areas dated August 26, 2018, accessed with Digital Map Products' Land Vision service.

Aerial Image 4—Northern cultivation areas dated November 12, 2018, accessed with Digital Map Products' Land Vision service.

Aerial Image 5—Northern cultivation areas dated October 26, 2019, accessed with Digital Map Products' Land Vision service.

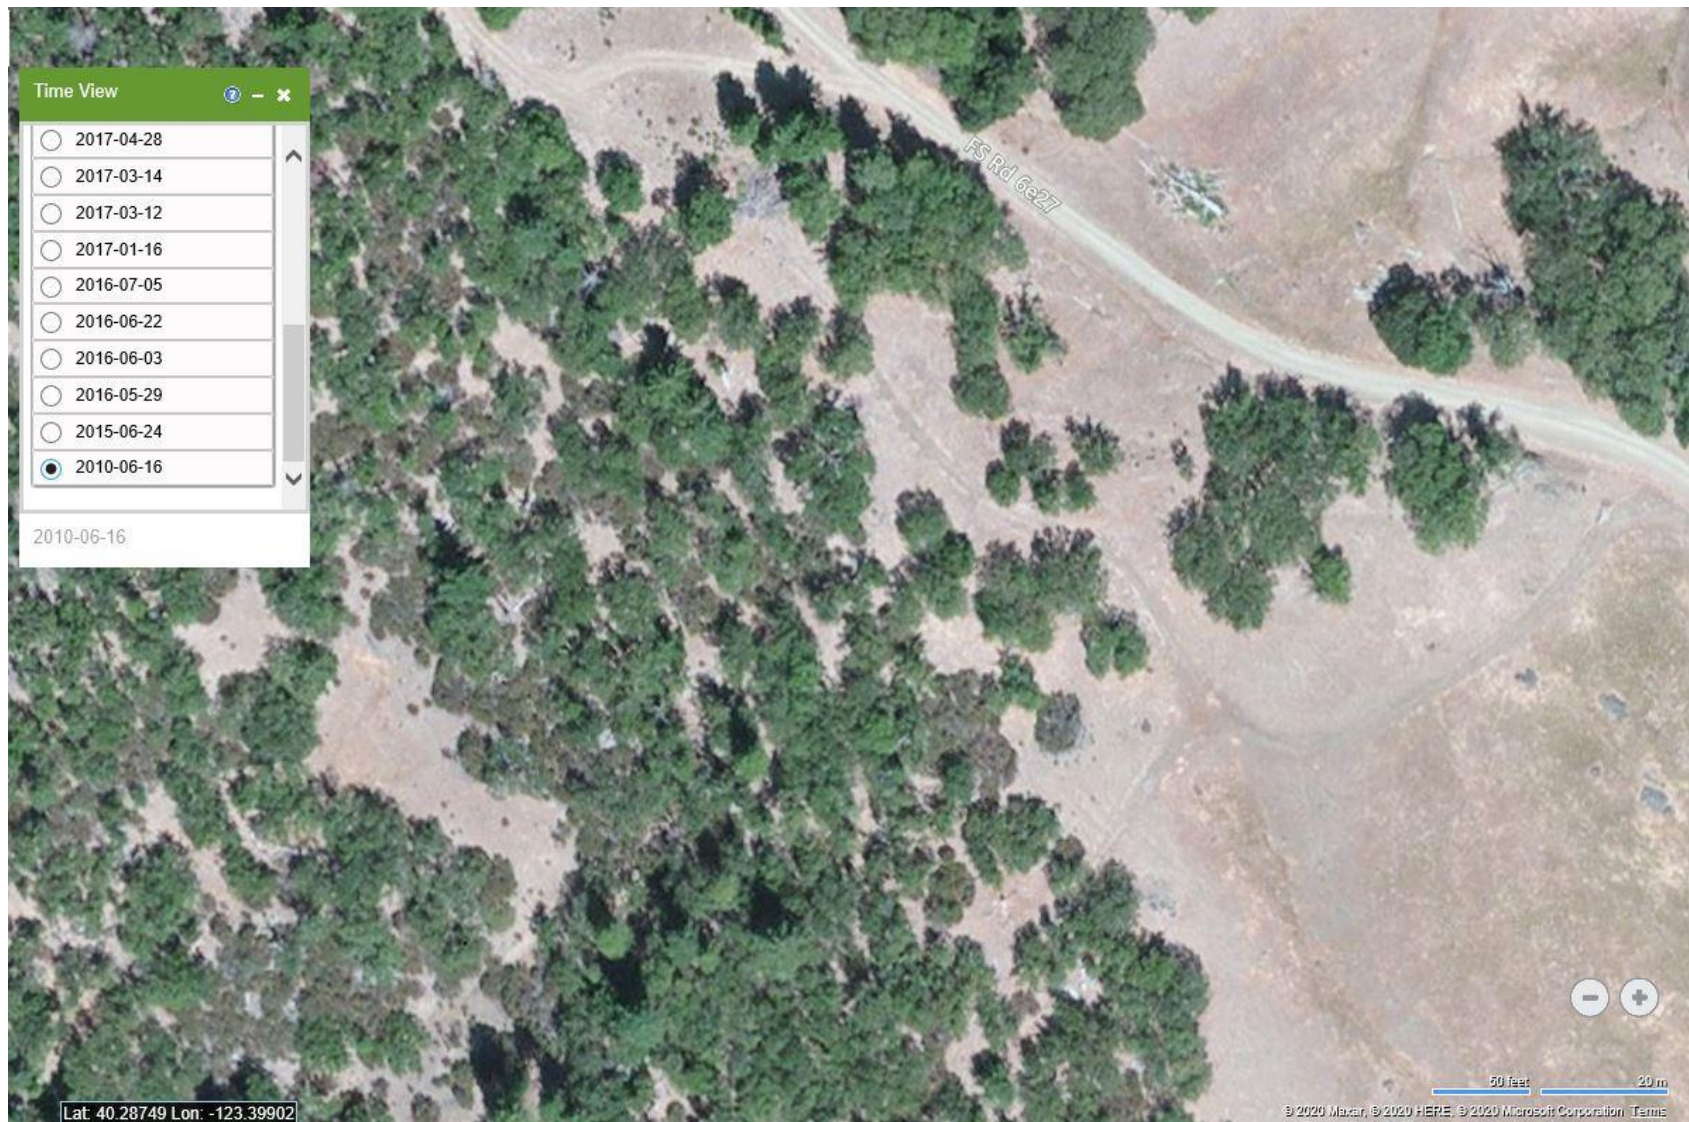
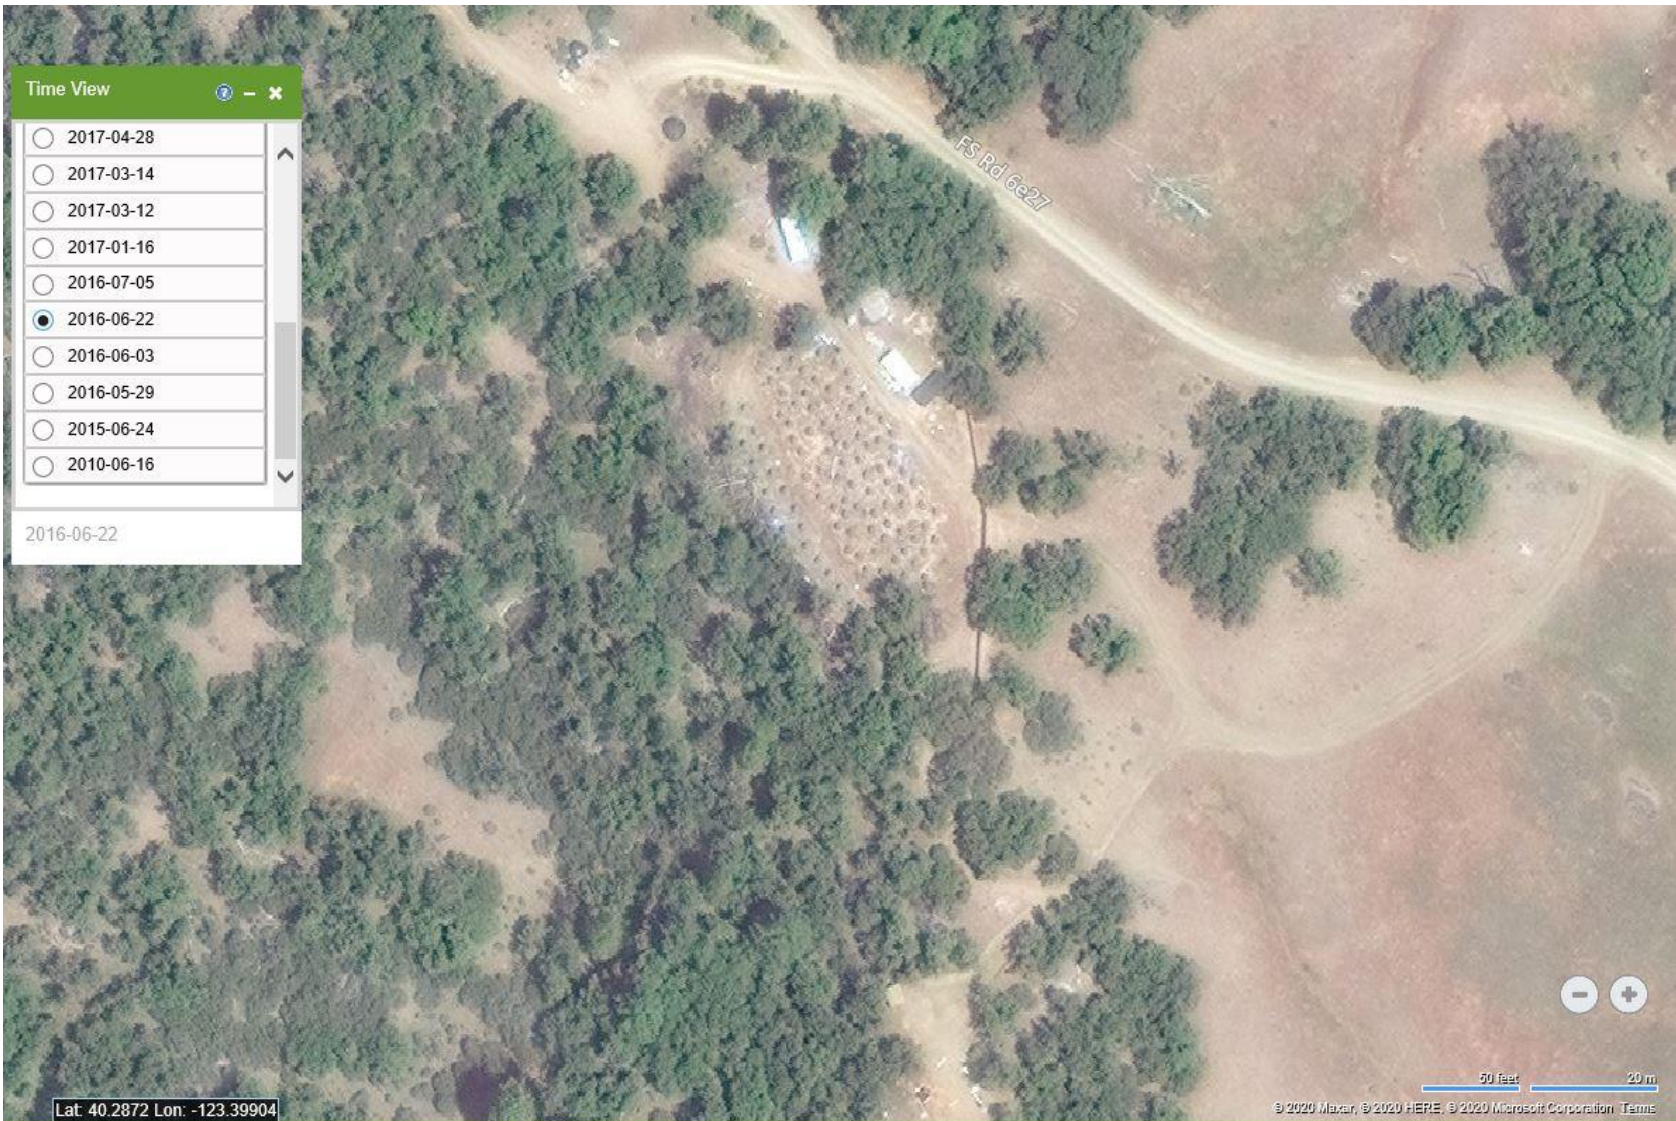
Aerial Image 6—Southern cultivation areas dated June 16, 2010, accessed with Digital Map Products' Land Vision service.

Aerial Image 7—Southern cultivation areas dated June 24, 2015, accessed with Digital Map Products' Land Vision service.

Aerial Image 8—Southern cultivation areas dated June 22, 2016, accessed with Digital Map Products' Land Vision service.

Aerial Image 9—Southern cultivation areas dated June 23, 2017, accessed with Digital Map Products' Land Vision service.

Aerial Image 10—Southern cultivation areas dated August 26, 2018, accessed with Digital Map Products' Land Vision service.

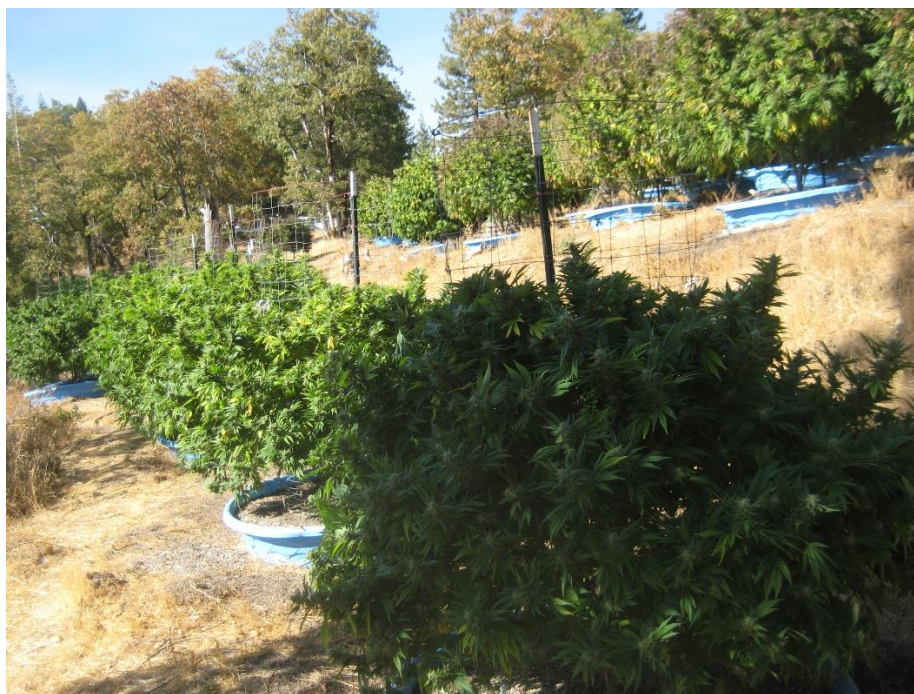
Photo 1—Rows of cannabis plants located at WQ 2.

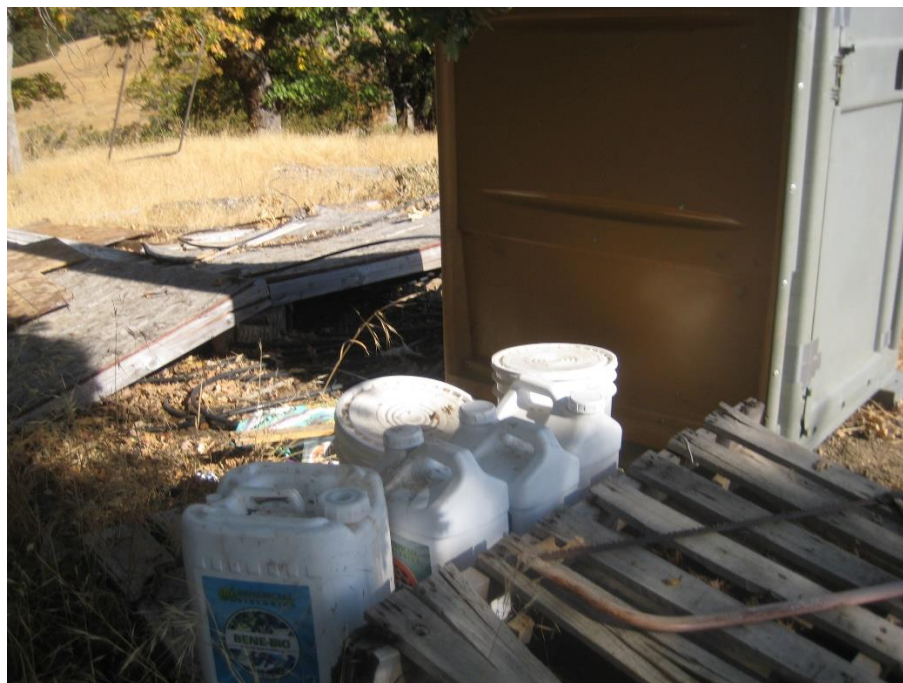
<i>Map point</i>	<i>Feature</i>	<i>Brief Description</i>	<i>Water Quality Concern</i>	<i>Associated Photo(s)</i>
WQ 2	refuse	refuse, fertilizer and chemical materials and cultivation waste uncontained on bare ground	threatened discharge of waste to water of the state	Photo 2 through Photo 5
WQ 3	toilet shed	pipe from toilet shed discharges to hillside	threatened discharge of waste to water of the state	Photo 6

I observed waste fertilizer containers uncontained on bare ground at WQ 2.

I observed a chemical toilet, which is an appropriate method of collecting human waste at WQ 2. I observed a flush toilet with pipe discharging to the ground surface at WQ 3, this is not an appropriate method for disposing human waste. I observed refuse uncontained at WQ 2 and WQ 3.

Photo 2—Chemical toilet and fertilizer containers at the north east edge of the cultivation area located at WQ 2.

1. Collect and dispose of or contain all refuse and cultivation-related wastes in a location and manner so as to minimize potential for these wastes to enter or be transported into receiving waters.

2. Store and contain all chemicals, including petroleum, fertilizer and/or pesticides properly to prevent spillage and discharge to receiving waters. Provide secondary containment for all petroleum products.

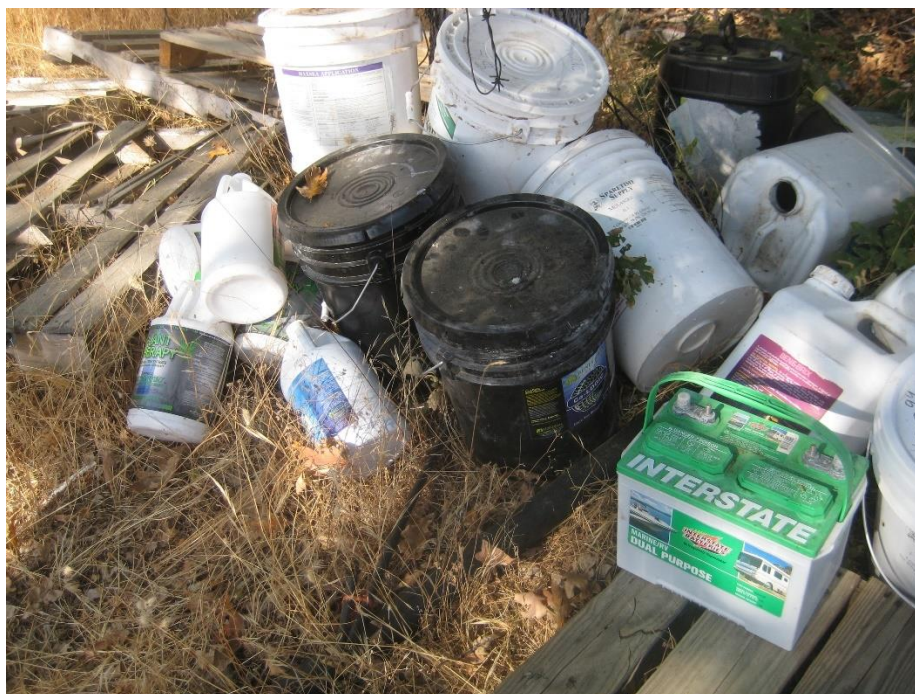
Photo 3—Waste fertilizer materials in the vicinity of WQ 2.

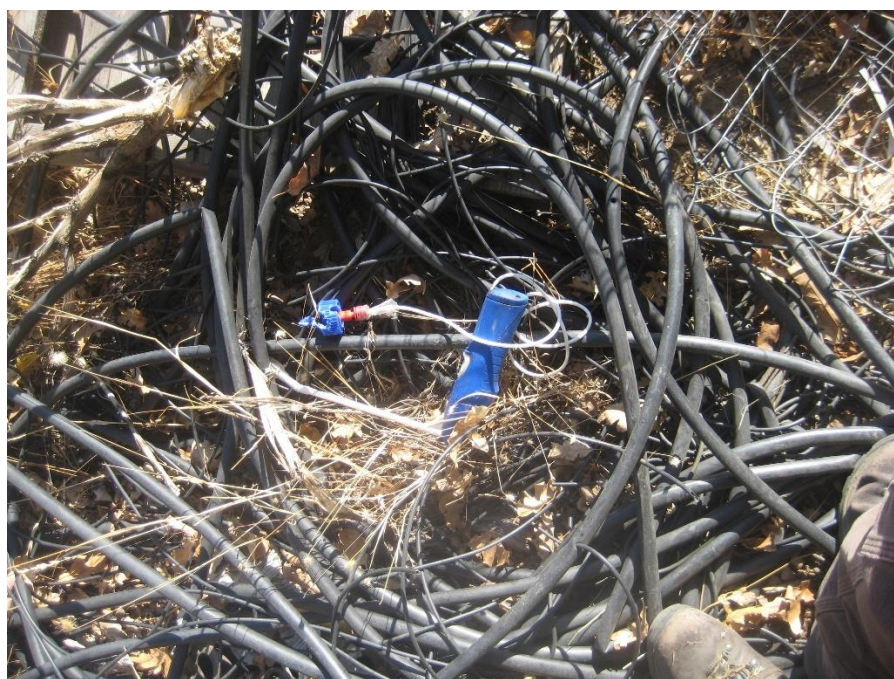
I observed cultivation waste uncontained on bare ground at WQ 2.

Photo 4—Pile of waste plastic in the vicinity of WQ 2.

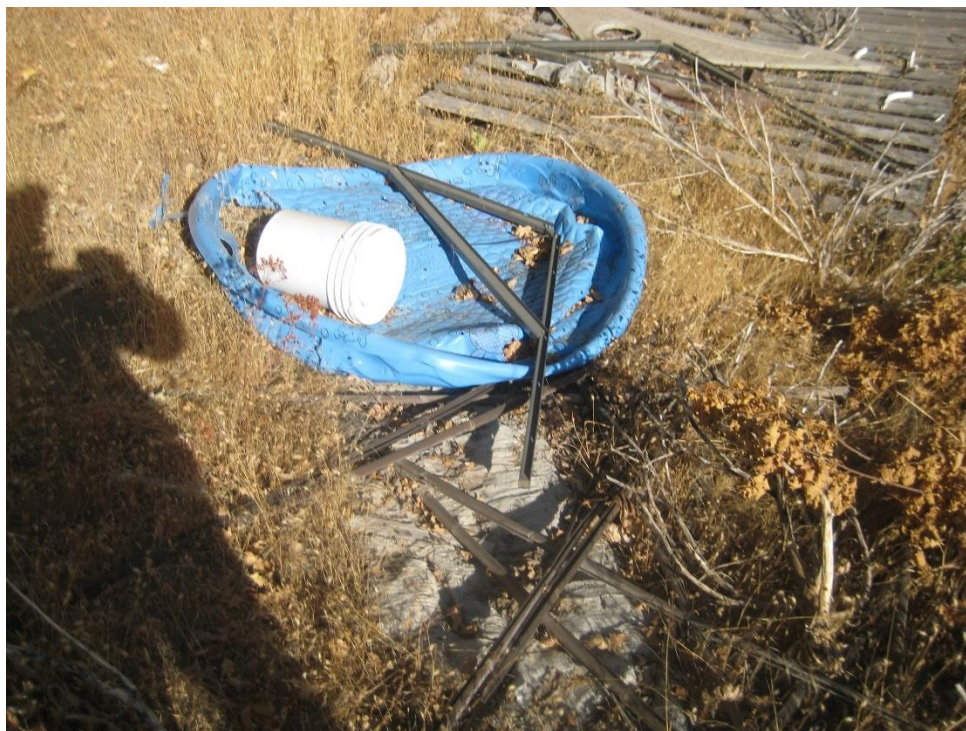
The above site map shows inspection points identified and discussed in this report. Patterns consistent with cannabis cultivation are visible at WQ 1, however I did not go to this location during the inspection. I accessed the property from Ruth Zenia Road to the east and headed west along a dirt access road to WQ 2. Here I observed a clearing at the top of a ridge. The clearing contained rows of cannabis plants growing in blue plastic tubs on terraced ground (Photo 1). In the northeastern corner of the clearing was a chemical toilet surrounded by waste fertilizer containers (Photo 2). I observed piles of waste chemical and fertilizer containers uncontained on bare ground (Photo 3), piles of plastic waste at the edges of the clearing (Photo 4), and other waste materials in a depression on the east side of the cultivation area (Photo 5)

Photo 5—Waste materials in a depression east of WQ 2

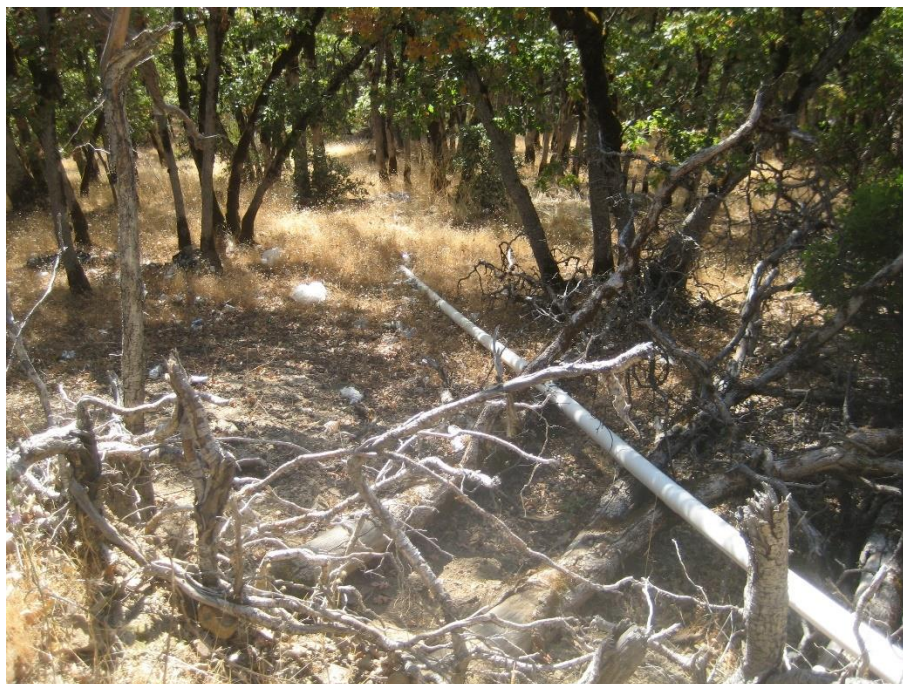
I walked south to a smaller clearing at the top of a ridge (WQ 3), which appeared to have been used for drying cannabis plants. I observed two sheds, one containing a shower and the other containing a flush toilet that discharged to the hillslope to the west (Photo 6). I observed that there was plastic and paper refuse scattered in the vicinity of where the pipe discharged. I walked northeast to WQ 4. Here I observed a single lane dirt road that was overgrown with grasses (Photo 7). Downslope from the road, I observed the form of a watercourse (Photo 8). I noted that if the road were used by vehicles, the protective layer of vegetation would be compromised and added mechanical abrasion would threaten to discharge fine sediment to receiving waters. However, I did not observe any evidence of recent vehicle use or rills or scour marks from stormwater erosion.

Photo 6—Looking west at where pipe connected to a shed with a flush toilet discharges to the hillslope among scattered refuse.

3. Discontinue use of and dismantle any outhouse/pit toilet/cesspool features and work with Trinity County to ensure that all domestic and human wastes are collected and disposed of consistent with applicable County requirements.

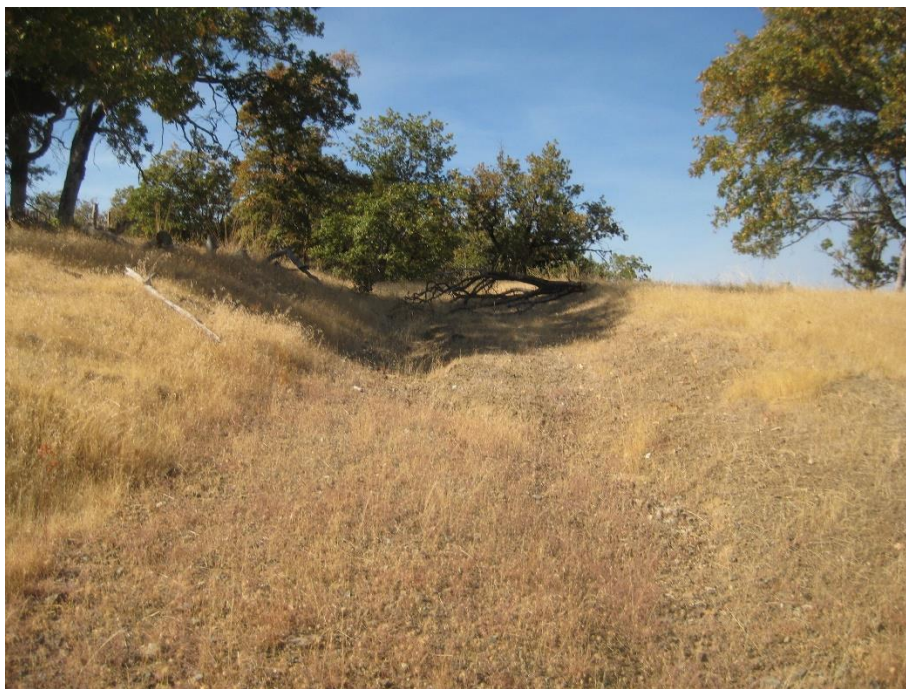
I noted a historical road at WQ 4 that may threaten water quality if used by vehicles. Other than this, I did not observe any water quality concerns associated with site maintenance, erosion control and drainage features.

Photo 7—Looking north from WQ 4 at the impression of a former road.

4. Monitor the road at WQ 4 for signs of increased erosion. Do not put this road back into service; promote regrowth of native vegetation in the area.
5. In the event that the property owner and/or tenant(s) propose in the future to develop or use the Property in a manner or method that will or may result in a discharge of waste to waters of the state in the future, staff recommend that the owner(s)/tenant(s) be aware of and comply with relevant regulatory requirements for water quality protection. For example, Water Code section 13260 requires that a person discharging waste, or proposing to discharge waste, within any region that could affect the quality of the waters of the state, other than into a community sewer system shall file with the appropriate regional board a report of the discharge. Further, Water Code section 13264 states, in part: "No person shall initiate any new discharge of waste or make any material changes in any discharge...prior to the filing of the report required by Section 13260." In addition, projects involving the disturbance of an acre or more of land are subject to regulation under the State Water Board's Construction General Stormwater permit, and projects involving dredge or fill in waters of the United States are subject to regulation under Clean
